# **2017 Dry Weather Screening Report**

## **APDES Permit No. AKS052558**

### **MUNICIPALITY OF ANCHORAGE**

### **WATERSHED MANAGEMENT SERVICES**

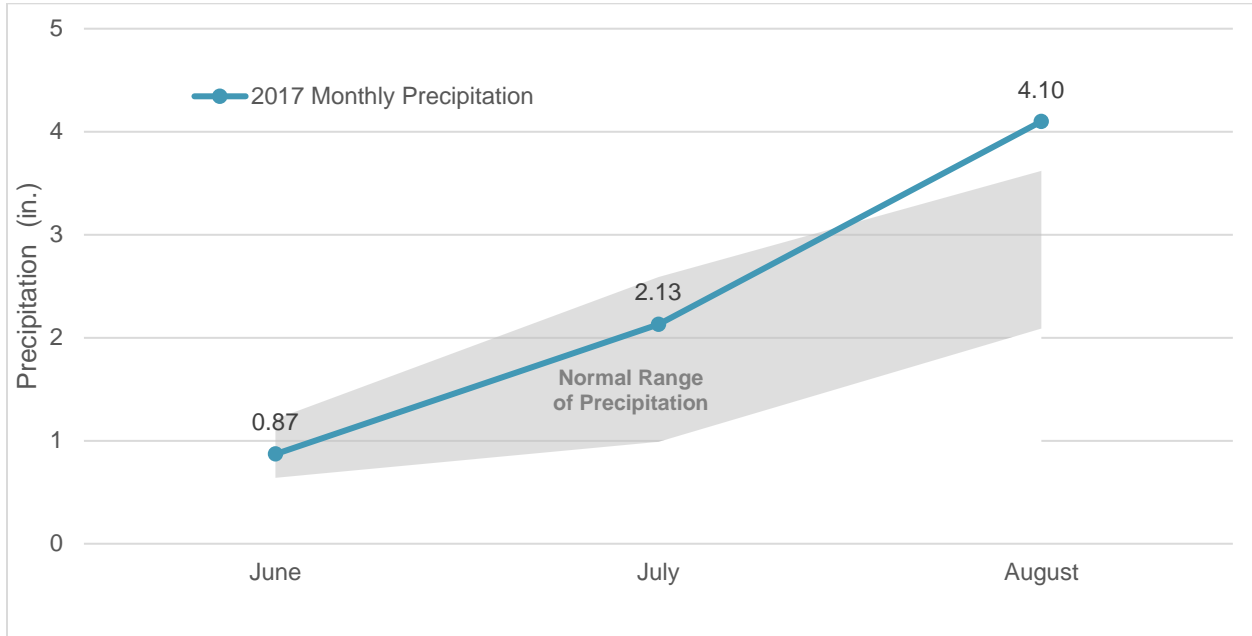
**Figure 1. Monthly Precipitation in Anchorage, Summer 2017**

**Notes:** 2017 monthly precipitation data recorded at Ted Stevens International Airport. Source: NWS 2017b. Normal range of precipitation shown is the range between the 25<sup>th</sup> and 75<sup>th</sup> percentiles of monthly precipitation averages recorded at the Ted Stevens International Airport for the 30 year period from 1981 to 2010. Source: NOAA 2016.

timing when necessary (NWS 2017a). Field sampling occurred on four days in June and August. Figure 2 shows the daily precipitation and 48 hour running total precipitation for summer 2017. The dates when field sampling occurred are indicated by the black arrows.

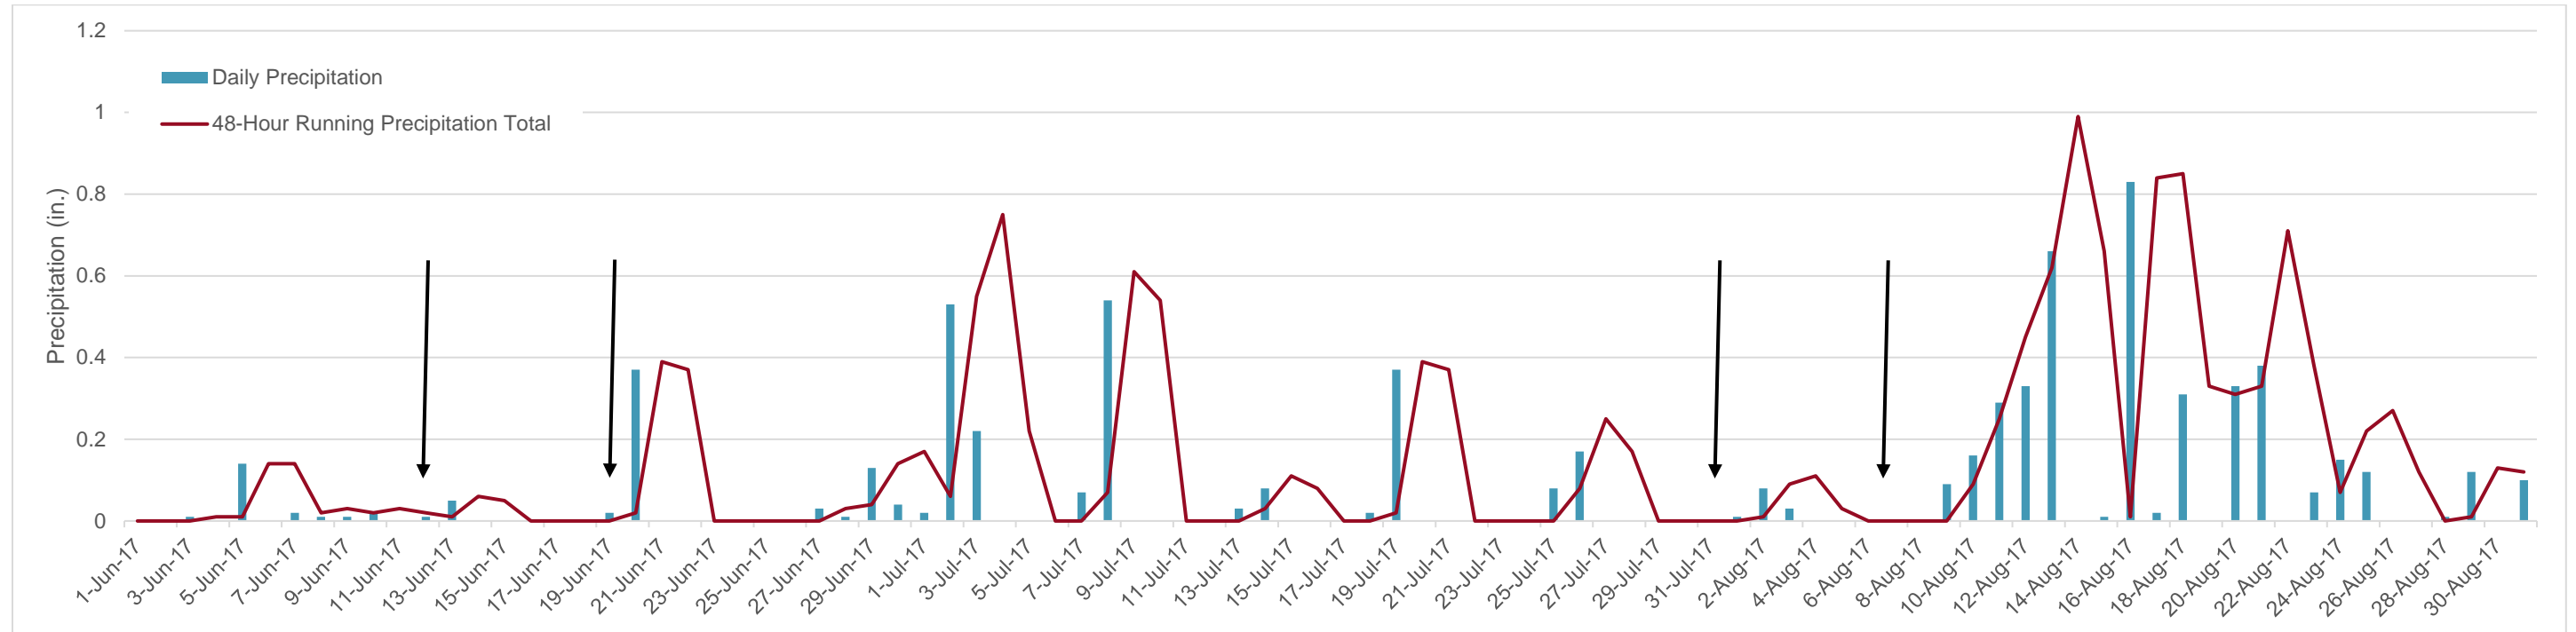
Figure 2. Daily Precipitation in Anchorage, Summer 2017

**Notes:** Daily precipitation data recorded at Ted Stevens International Airport. Source: NWS 2017b.  
Black arrows indicate sampling dates.

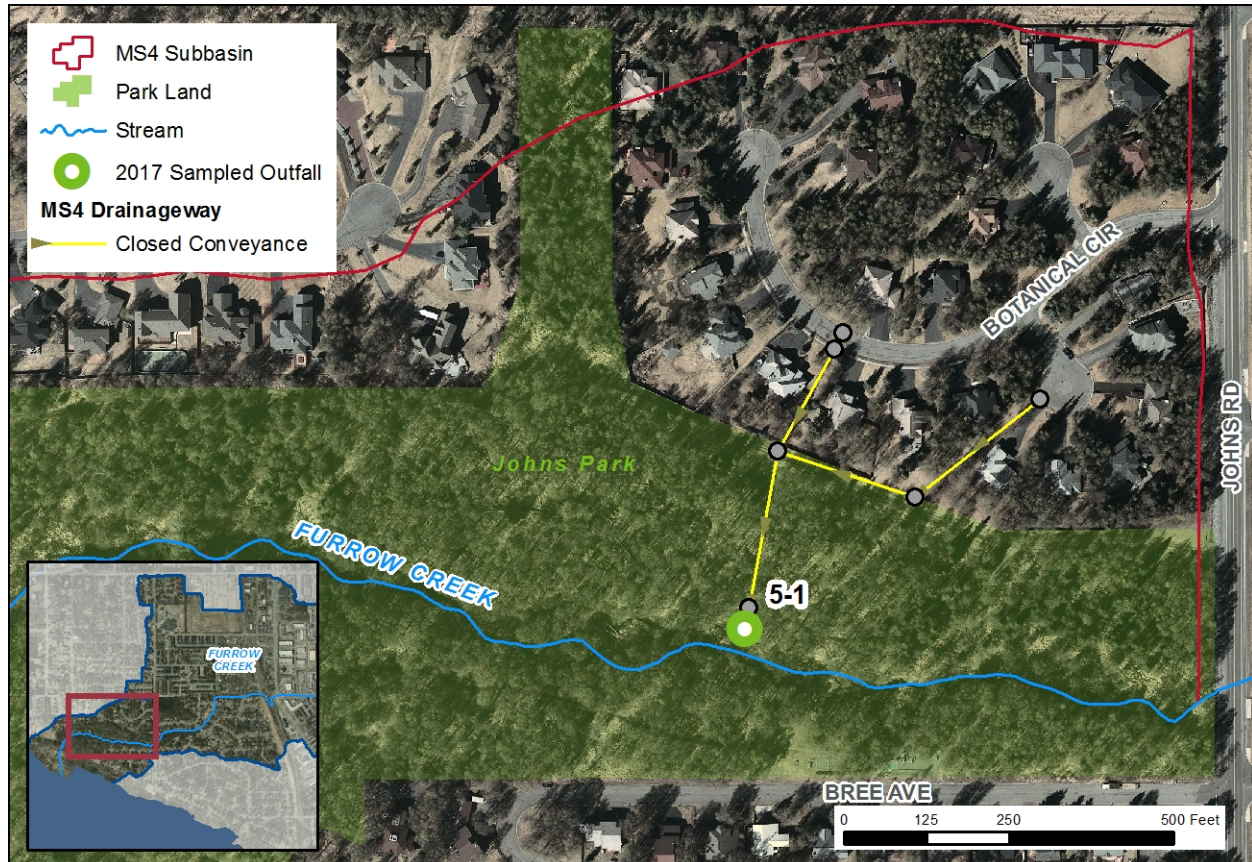
**Figure 3. MS4 Network 1104 Draining to Outfall 5-1 in Furrow Creek Watershed**

Outfall 5-1 is connected to network 1104, which drains Botanical Circle and Hansa Rose Circle within the Botanical Garden neighborhood off Johns Road. A paved path along the north edge of Johns Park and many social trails through the woods on both sides of Furrow Creek are regularly used by pedestrians, cyclists, and dog walkers.

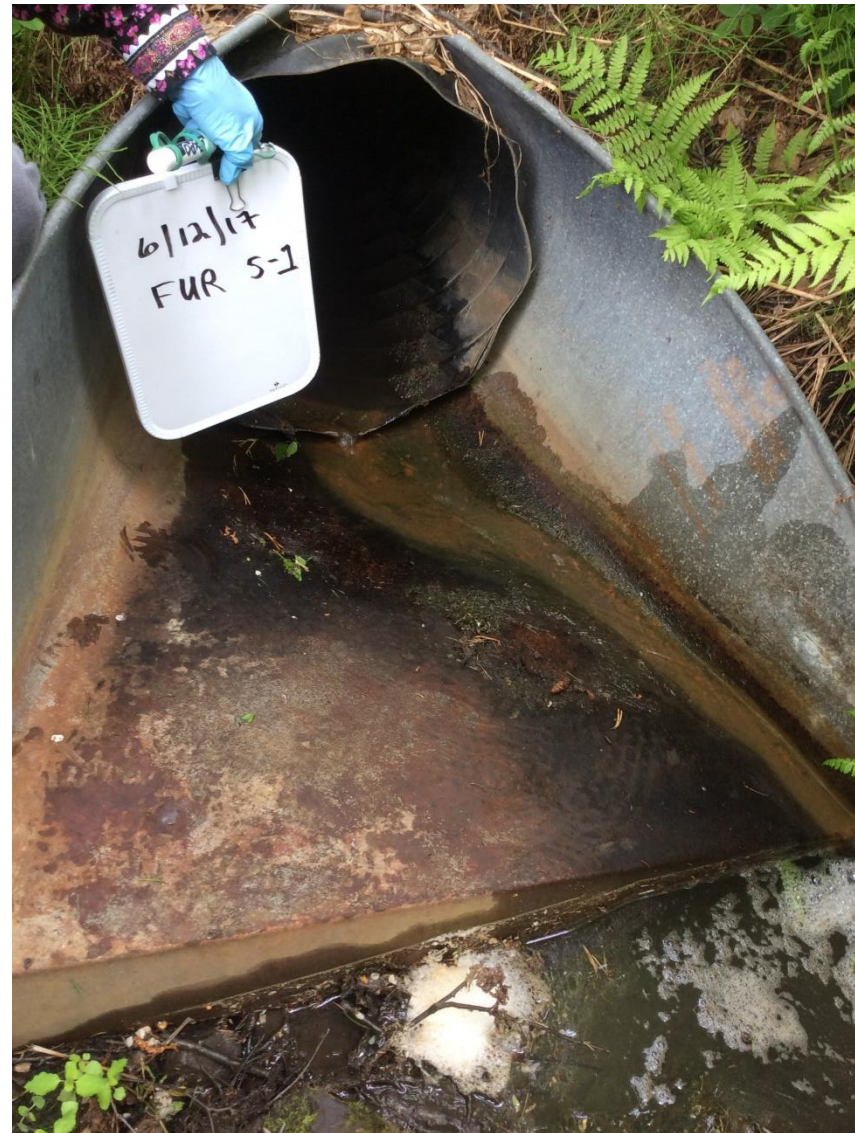
Furrow Creek 5-1. June 12, 2017.

Outfall Code	Latitude	Longitude	Location Description and Notes
<b>Furrow Creek</b>			
5-1	61.10603	-149.88295	North bank, at Johns Park. Outfall is at social trail off paved path south of Botanical Cir. Well-defined flow path to creek. Steady flow with some foam during reconnaissance visit.
1345-1	61.10855	-149.87100	North bank, at Division St. Outfall discharges into flow path approximately 175 feet north of creek. Outfall is in good condition. Flow path routed through culvert under trail along creek; culvert is slightly eroded. Steady flow, slight odor of laundry detergent during reconnaissance visit.
1359-1	61.10855	-149.86822	South bank, at Beachcomber Dr. Sod and grass are overhanging outfall. Outfall is in good condition. Steady flow, slight metallic odor during reconnaissance visit.
306-1	61.10813	-149.86435	South bank, at Huffman Rd. and Old Seward Hwy. Outfall is in concrete headwall below traffic circle. Flow path through wetland to creek. Trickle flow.

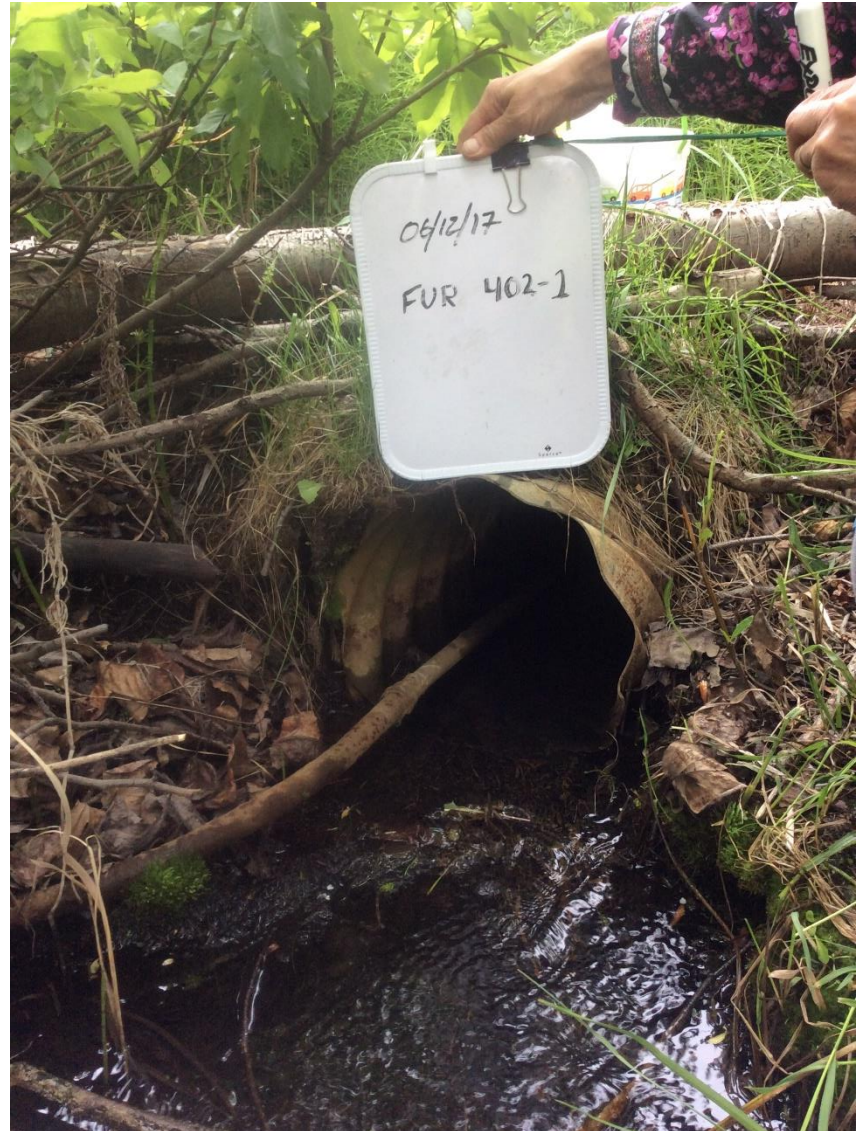
Furrow Creek 402-1. June 12, 2017.

402-1	61.11274	-149.83145	Northwest corner of wetland at private park at Alderwood Loop and Woodway Dr. No outfall at location shown in HGDB. Sample collected from EOP 20 feet to west, mapped in HGDB as network node but not as outfall. Outfall in good condition.
332-1	61.11240	-149.83083	Southeast corner of wetland at private park at Alderwood Loop And Woodway Dr. No outfall at location shown in HGDB. Sample collected from EOP 30 feet to west, mapped in HGDB as network node but not as outfall. Outfall in good condition.
<b>Eagle River</b>			
<b><i>Eagle River Mainstem</i></b>			
1335-1	61.29961	-149.54223	North bank, at pedestrian tunnel below Eagle River Loop Rd. Outfall in concrete headwall, discharges to flow path constructed with rock gabions. Water flows for approximately 100 feet in flow path, then infiltrates into gabions. Outfall and flow path in good condition.
303-1	61.29799	-149.53480	North bank, outfall is along trail below Little Cape Cir. EOP is located at terminus of mapped closed conveyances and flow path conveys discharge to west and south (not to south as mapped in HGDB). High flow. Outfall in good condition.

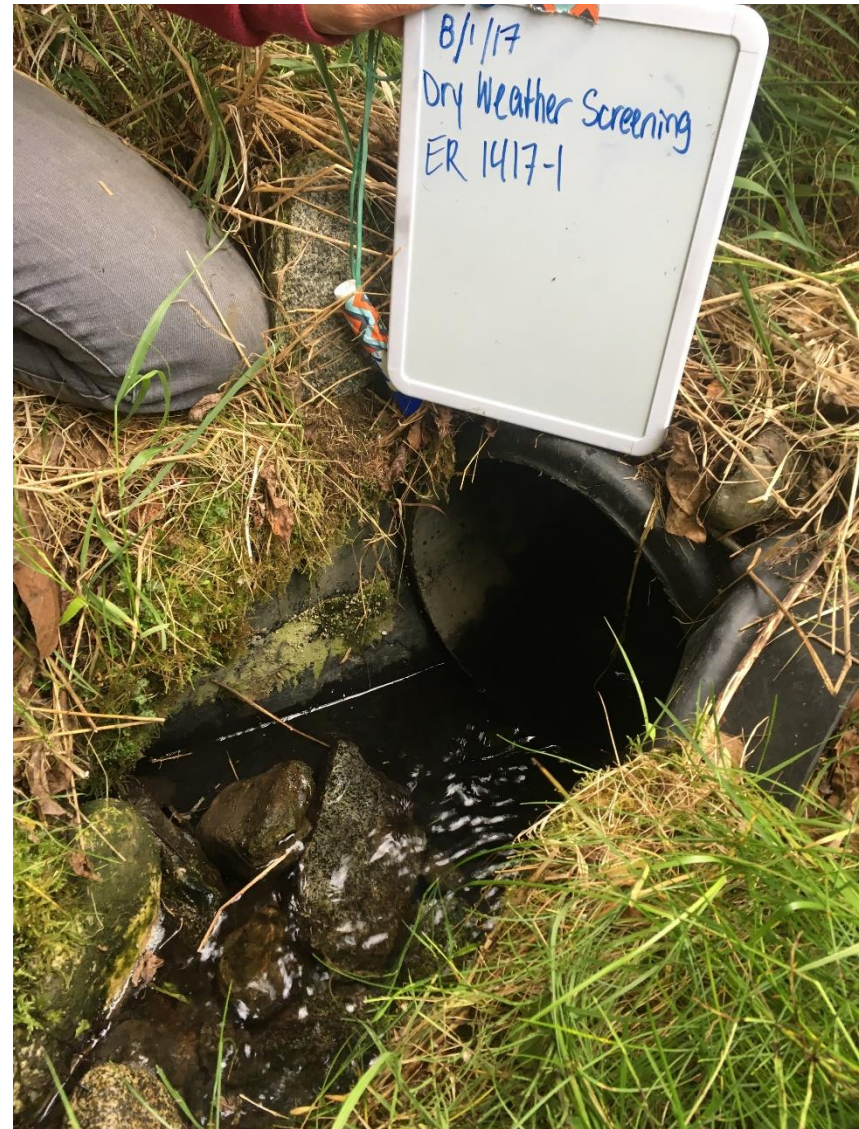
Eagle River 1417-1. August 1, 2017.

1417-1	61.29864	-149.51362	North bank, south of Driftwood Bay Dr. at Meadow Park Cir. Well-defined flow path below EOP. Steady flow. Outfall in good condition.
<b>Eagle River</b>			
<b><i>Meadow Creek</i></b>			
646-71	61.31722	-149.55439	South bank, west of Chain of Rock St. Outfall is approximately 150 feet farther downstream than shown on HGDB. Good condition.
1375-99	61.31725	-149.55412	North bank, west of Chain of Rock St. Unnamed outfall discharging into Meadow Creek. High flow. No outfall or connected network shown on HGDB (as of October 6, 2017), HDR assigned temporary ID in 2013. No evidence of network observed up Chain of Rock St. to Kahiltna Dr.
<b>Campbell Creek</b>			
105-1	61.17242	-149.86760	South bank, east of Old Seward Hwy. across from the Peanut Farm. Outfall appears to have been reconstructed since last sampled in 2016. Good condition.

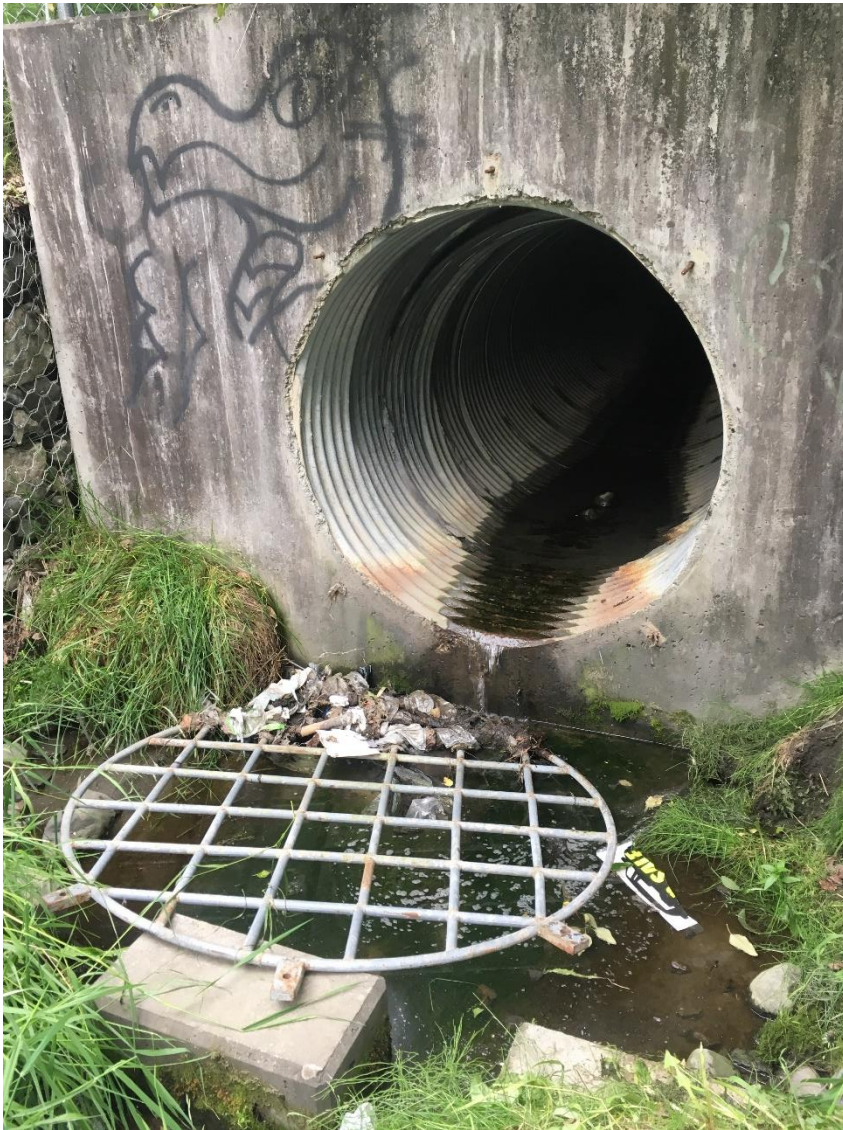
Eagle River 1335-1. August 1, 2017.

grate has fallen off. Lots of urban debris in grate + flow path.  
 Water not flowing directly to river. Infiltrates in to gabions ~ 20 ft below EOP.  
 Trash in flow path, evidence of flow during high water.  
 Flow path vegetated w/ Rebet + Cal can to ~ 100 ft below EOP.
